# **Pinellas Environmental Restoration Project**

Semiannual Progress Report for the Young - Rainey STAR Center's 4.5 Acre Site December 2007 through May 2008

June 2008

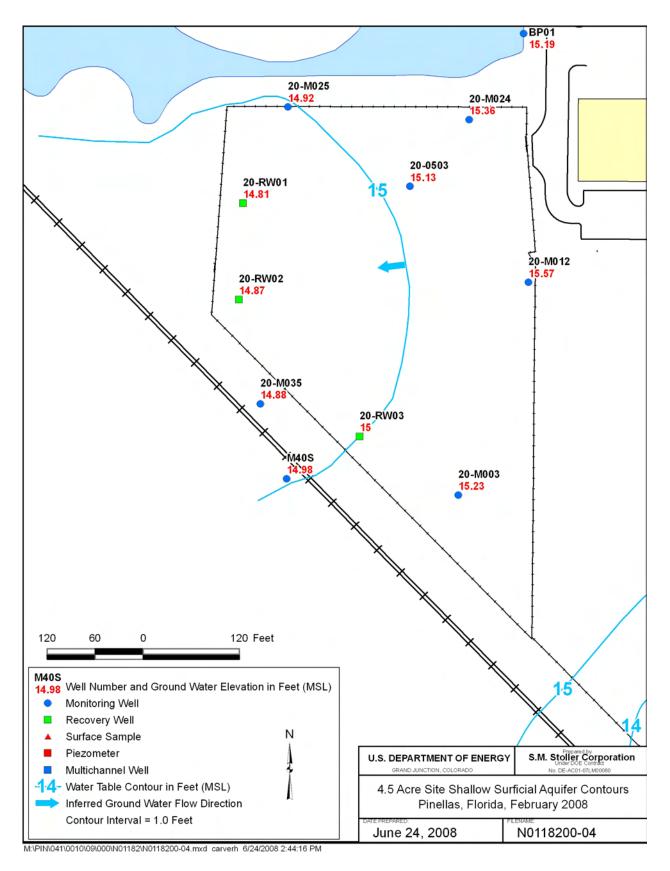
Figure 3. Groundwater Elevations and Shallow Surficial Aquifer Flow, 4.5 Acre Site, February 2008

On February 26, 2008, depth-to-water measurements were taken in all monitoring wells and former recovery wells at the 4.5 Acre Site. The depth to water in each well was measured with an electronic water-level indicator. The groundwater elevation data are listed in Table 1. Surface water elevations for Pond 5 (southeast of the 4.5 Acre Site), the West Pond (to the east), and the pond immediately north of the 4.5 Acre Site are listed in Table 2. The water elevation data were used to construct contours of water levels in the shallow and deep portions of the surficial aquifer (Figure 3 and Figure 4). Groundwater in the shallow surficial aquifer generally flows to the west, and groundwater in the deep surficial aquifer flows to the west-northwest.

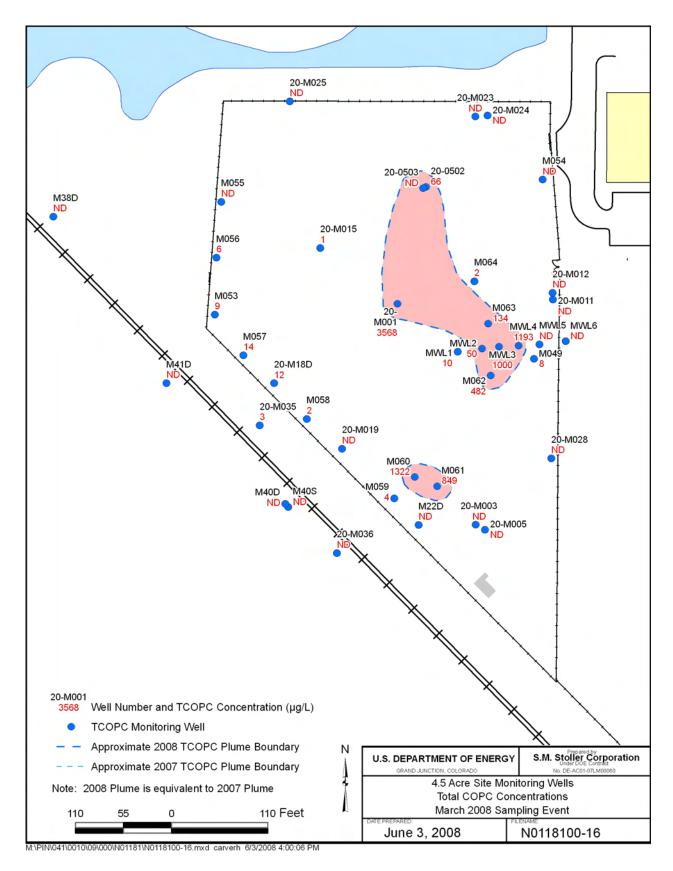
Figure 5. 4.5 Acre Site TCOPC Concentrations March 2008 Sampling Event

Table 4 presents individual contaminants of potential concern (COPC) and total COPCs (TCOPCs) concentrations in samples collected from wells at the 4.5 Acre Site. The previous two semiannual results are included in Table 4 for comparison. Figure 5 shows the TCOPCs concentrations for March 2008.

Plume maps were generated for TCOPCs (Figure 5) and the individual site COPCs: TCE (Figure 12), cDCE (Figure 13), VC (Figure 14), and benzene (Figure 15). The inferred plume boundaries for the individual compounds are the respective CTLs of the compounds. Concentrations that are below the CTL are not included in the individual compound plumes. The TCOPCs map is a summary of the individual compound maps. The plume maps also show the plume boundary from the previous year to show any changes over the last year.

In summary, the 2008 contaminant plume at the 4.5 Acre Site is similar in size to the 2007 plume. No COPCs were detected above the CTL in off-site wells. The plume appears stable in terms of area.

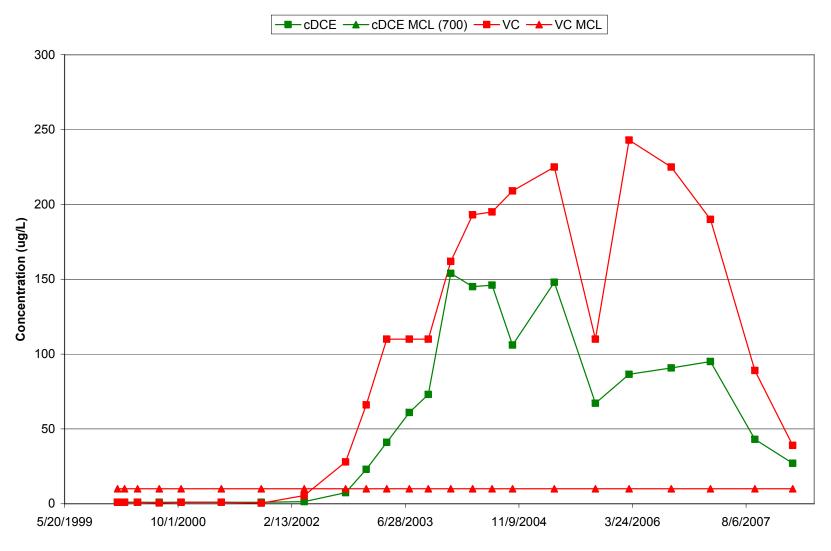
Figure 6. cDCE and VC in PIN20-0502

Figure 6 and Figure 7 show the cDCE and VC concentration trends in wells PIN20–0502 and –M001, respectively. These two wells, located hydraulically downgradient from the area of highest contaminant concentrations, have shown increasing concentration trends over the last few years. This appears to be a result of past operation of the biosparging system, as described in previous reports. However, it appears that the contaminant concentrations in both wells are now decreasing.

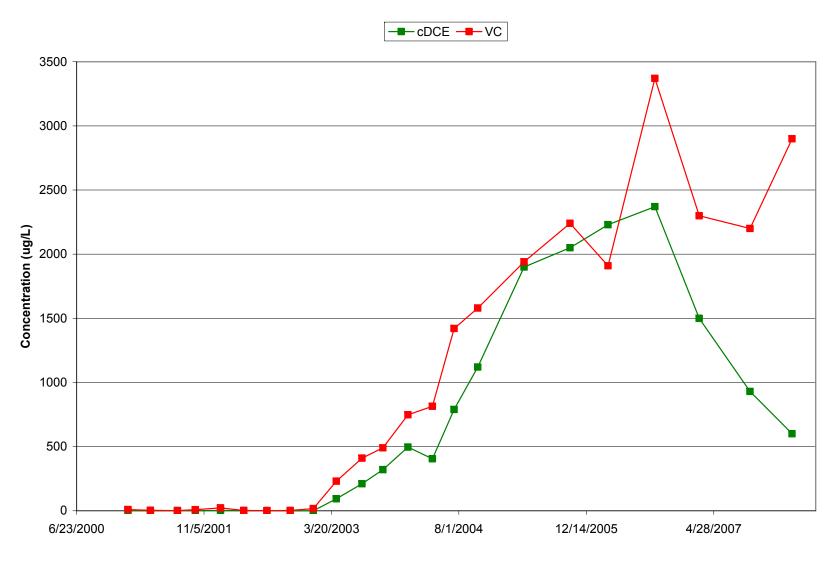
Figure 7. cDCE and VC in PIN20-M001

The maximum TCOPCs value detected in February and March was 3,568 micrograms per liter ( $\mu$ g/L) at PIN20–M001. The compound detected at the highest concentration in PIN20–M001 was VC at a concentration of 2,900  $\mu$ g/L.

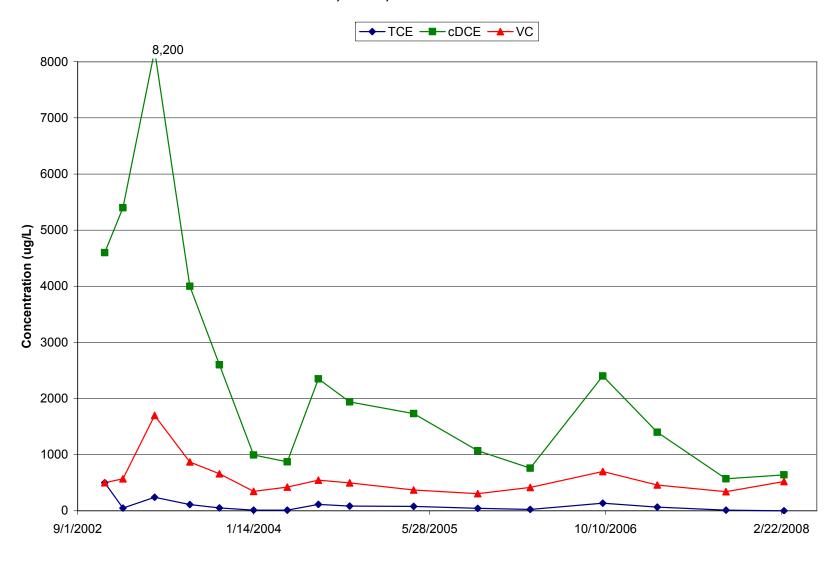
Figure 8. TCE, cDCE, and VC in PIN20-MWL4

Figure 8 and Figure 9 show TCE, cDCE, and VC concentration trends in wells PIN20–MWL4 and –M063. These two wells are in the area of highest contaminant concentrations on the eastern side of the site. Concentrations in these wells have shown an overall decreasing trend. The contaminant concentrations in well M063 decreased significantly since March 2007. This change may be due to a change in the local hydrology caused by numerous soil borings installed during the summer of 2007.

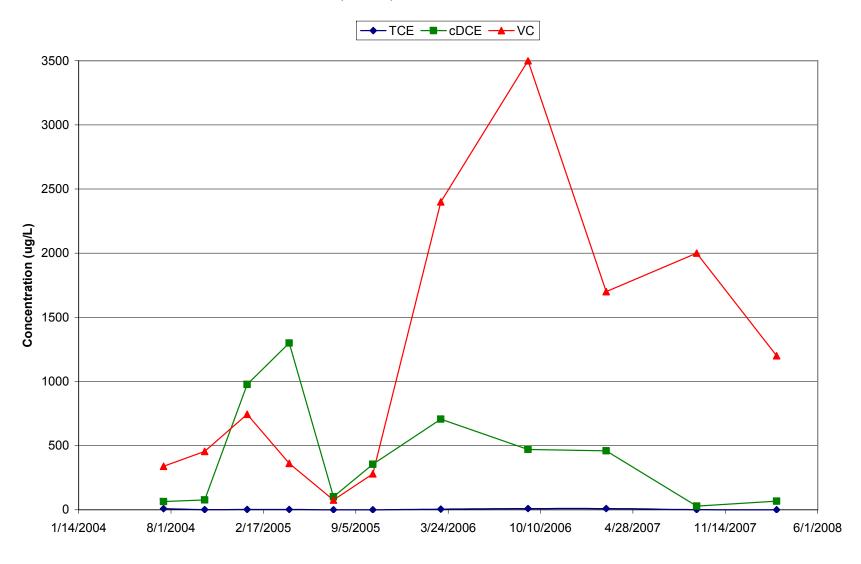
Figure 10. TCE, cDCE, and VC in PIN20-M060

Figure 10 and Figure 11 show TCE, cDCE, and VC concentration trends in wells PIN20–M060 and –M061. These wells are in the area of elevated contaminant concentrations near the southwest property boundary. The contaminant concentrations in these wells do not show distinct trends, with both wells exhibiting significant increases and decreases over time.
